STM32L496xx/4A6xx device errata

Applicability

This document applies to the part numbers of STM32L496xx/4A6xx devices and the device variants as stated in this page. It gives a summary and a description of the device errata, with respect to the device datasheet and reference manual RM351. Deviation of the real device behavior from the intended device behavior is considered to be a device limitation. Deviation of the description in the reference manual or the datasheet from the intended device behavior is considered to be a documentation erratum. The term “errata” applies both to limitations and documentation errata.

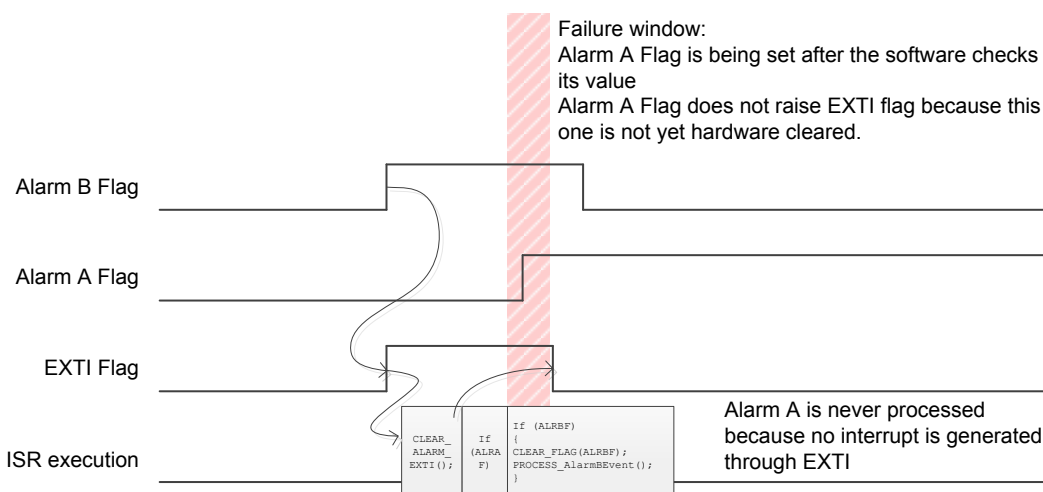
Figure 1. Masked RTC interrupt

The following code example and figure illustrate the failure mechanism: The Alarm A event is lost (fails to generate interrupt) as it occurs in the failure window, that is, after checking the Alarm A event flag but before the effective clear of the EXTI interrupt flag by hardware. The effective clear of the EXTI interrupt flag is delayed with respect to the software instruction to clear it.

In the interrupt service routine, apply three consecutive event flag checks - source one, source two, and source one again, as in the following code example:
